THE IMPACT OF STAGNANT WATER ON THE CORROSION PROCESSES IN A PIPELINE

Marjan Suban, Robert Cvelbar, Borut Bundara

Institute of metal constructions, Mencingerjeva 7, 1001 Ljubljana, Slovenia
marjan.suban@imk.si

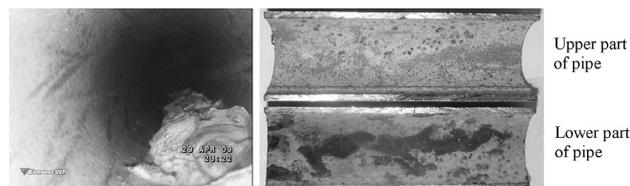
Figure 3: Corrosion products on the lower part of the pipe in its interior (left) and the longitudinally cut pipe (right)

When inspecting the pipe interior the first finding was that it was coated with a carbohydrate biofilm. Corrosion, which is much more intense in the lower part of the pipe (see **Figure 3**), shows that the corrosion process started mainly due to stagnant water and an incompletely drained water-supply system. This shows the explicit effect of stagnant water, probably after the hydrotest, or at another time, when the system was, for a longer period, only partially drained. The smaller quantity of stagnant water was a very appropriate medium for the growth of microorganisms and the further development of MIC. The microorganisms dissolve zinc and iron and even lower-quality stainless steel (e.g., 18Cr-8Ni austenitic stainless steel AISI 304) does not passivate in such a medium ⁸.

- When designing and constructing a water-supply system a blind branch should be avoided. The design of horizontal pipelines needs to be "self-draining".
- The pipeline must be constructed so that the velocity of the fluid flow is at least 1.5 m/s.
- Only chemically treated water should be used to fill the fire-protection sprinkler system.
- Demineralized drinking water should be used to carry out the hydrotest. As soon as possible after the completion of the hydrotest, it is necessary to drain and dry the pipeline.

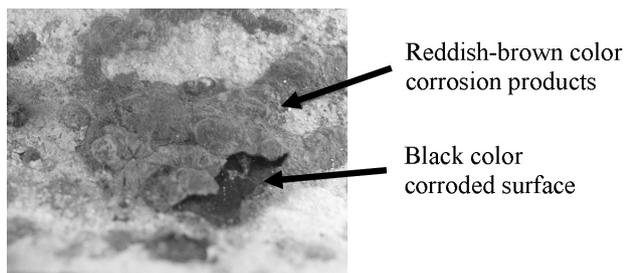
The color of the corrosion products is an essential indicator in the investigation of MIC. The reddish-brown deposits with a black corroded surface in **Figure 4** may

Figure 4: Corrosion products on the surface of the pipe

be good indicators of the SRB and iron-oxidising bacteria. The black corroded surface under the carbohydrate biofilm was an indication of the iron sulfide formation. A chemical analysis of the corrosion products was not performed. A distinctive smell of rotten eggs, which indicates hydrogen sulfide gas produced by the SRB, arises during the removal of the biofilm.

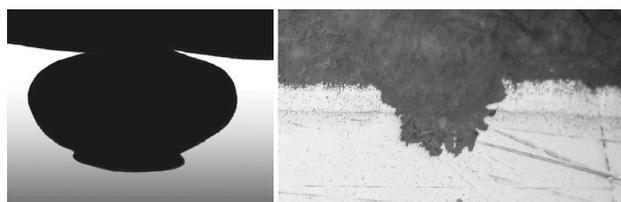
Figure 5: Cross-section illustration of an ink-bottle-type pit noted in the case of stainless steel (left) ¹⁰ and the cross-section of the pit in the investigated case of galvanized carbon steel (right)

At the next stage the study was extended with a metallographic examination of the cross sections of corroded sites. The researchers in ¹⁰ described ink-bottle-shaped pits in the stainless steel as diagnostic of MIC (**Figure 5** left). This, in our case (**Figure 5** right), was not confirmed, but it is true that in our case the material was galvanized carbon steel. After the breakthrough of the zinc protective layer, the corrosion of the underlying steel started. It is possible that the further growth in the depth of the corrosion in the carbon steel could develop a similar form as in **Figure 5** (left).

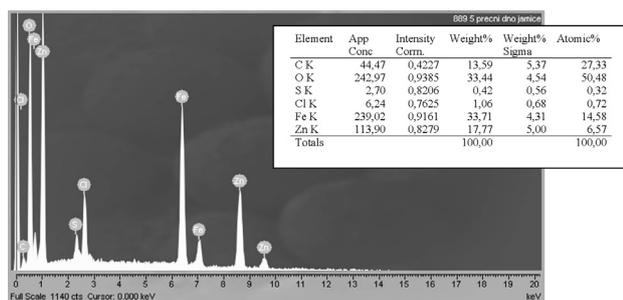
The corrosion products formed in the pit were analyzed with the EDX method and the graph in **Figure 6** shows peaks for iron (Fe), zinc (Zn), oxygen (O) and sulfur (S). As already shown by Equation 7, in the MIC iron sulfide (FeS) was formed as a corrosion product. For this reason, the EDX analysis of the corrosion products detected some amount of sulfur ($w = 0.42\%$), which is characteristic of this type of corrosion. The presence of sulfur in conjunction with the zinc was also suggested by the presence of zinc sulfide (ZnS) in the corrosion products. In addition, we have also found a significant amount of chlorine in the corrosion products, probably in the form of Cl⁻ ions. Thus, the large amount of chlorides is probably due to the implementation of chlorine shocks in the water supply system. The effect of chlorine on the creation of new corrosion pits and the deepening of the

Figure 6: EDX analysis of the corrosion products formed on the galvanized steel surfaces with microbiologically influenced corrosion

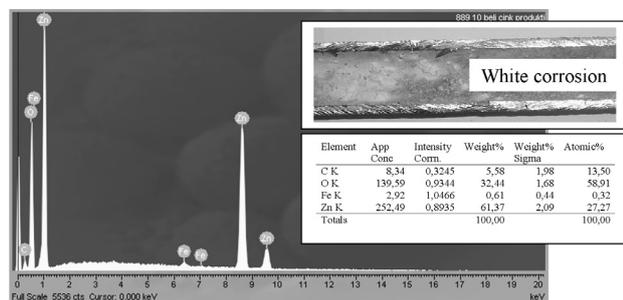
Figure 7: EDX analysis of the corrosion products and photograph of pipe section (top right) with the white corrosion of galvanized steel

For a comparison, we also analyzed a water pipe on which we could only find traces of white corrosion (**Figure 7**, top right). From the analysis of the corrosion products on the galvanized surface we found that the corrosion products consisted only of the products of zinc with the oxygen bound as zinc hydroxide ($Zn(OH)_2$) (**Figure 7**). We have also found traces of iron. As the proportion of iron in these corrosion products was very small, we concluded that it originated from the lower layers of zinc coating in which there can be from 7 to about 20 weight percent of iron (Fe) in the form of various intermetallic phases.
