## ROOT-CAUSE ANALYSIS OF SUPERHEATER-TUBE FAILURE

Martin Nad', Jiří Buzík, Tomáš Létal, Pavel Lošák

Brno University of Technology, Faculty of Mechanical Engineering, Institute of Process Engineering, Technická 2,  
616 69 Brno, Czech Republic  
nad@fme.vutbr.cz*Prejem rokopisa – received: 2016-07-15; sprejem za objavo – accepted for publication: 2016-09-15*

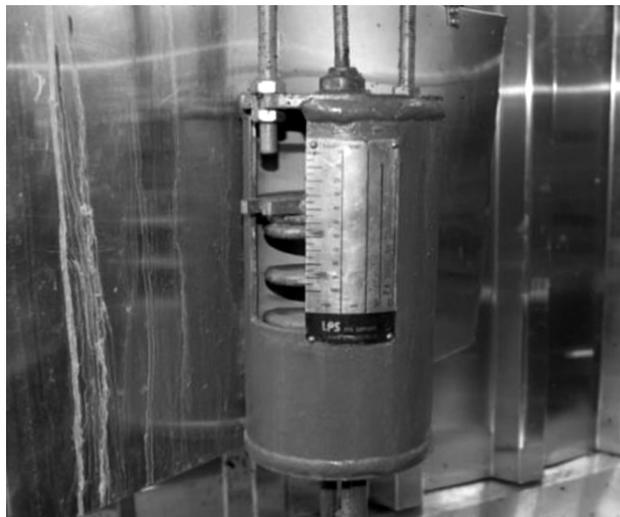
The U-shaped transition pipe has spring supports on three locations (**Figure 3**). Two of them are at the upper

part with displacements of 15 mm and 23 mm and one at the bottom part with a displacement of 75 mm.

**Figure 3:** Spring support of the transition pipe  
**Slika 3:** Vzmet v pretočni cevi

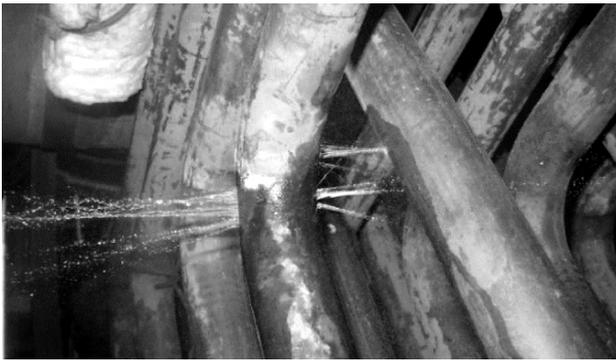
As mentioned, there are two main problematic areas. One of them includes the crack and the leakage on the superheater-P2 pipe bend (**Figure 4**).

**Figure 4:** Leakage on superheater-P2 pipe bend  
**Slika 4:** Puščanje na P2 pregrevalniku na krivini cevi

The first sample was taken from the pipe-bend area because the visual inspection revealed a horizontal crack (length 25 mm) on the pipe bend. This kind of crack cannot have been caused by the bending process. However, the manufacturing process should have influenced the material structure by lowering its corrosion resis-

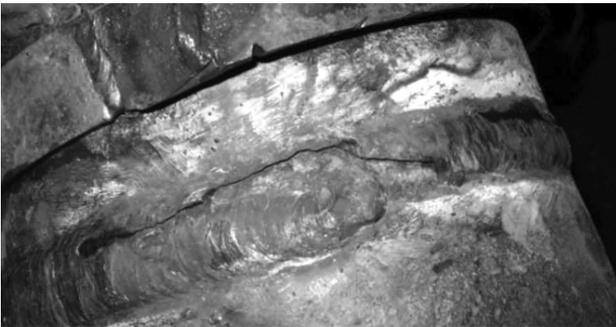
Another problem was the crack near the weld on the superheater collector with the U-shaped transition pipe (**Figure 5**). This problematic part had been repaired several times in the past, which can be seen in the figure.

**Figure 5:** Crack near weld on the superheater-P2 collector metallurgical analysis  
**Slika 5:** Razpoka blizu zvara na pregrevalniku P2 metalurška analiza zbiralnika

In order to avoid financial losses caused by repeated shutdowns and repairs, multiple corrective measures were proposed. The modification of the supports, which led to a stress reduction at the crucial areas, was performed. It was achieved by increasing the spring stiffness, which influenced the BC displacement. Due to this modification, each displacement was reduced by almost a half of the previous value (10 mm, 20 mm and 35 mm). Unfortunately, the results proved that the stress intensity decreases insufficiently and the spring modification is not sufficient to fix the problem. Another improvement could take the form of minimizing the displacements or removing the bottom support, identified as problematic. This would lead to a further decrease in the stress levels in the critical areas. However, these analyses are not included in the article.

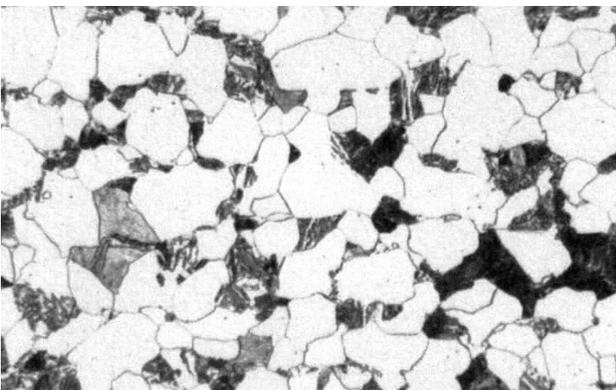
**Figure 6:** Micrograph of the basic material (500× zoom, etched with Nital)<sup>3</sup>  
**Slika 6:** Posnetek osnovnega materiala (500× povečava, jedkano z Nitalom)<sup>3</sup>

tance. The purity results of the analyses proved the material to be of a very good quality.

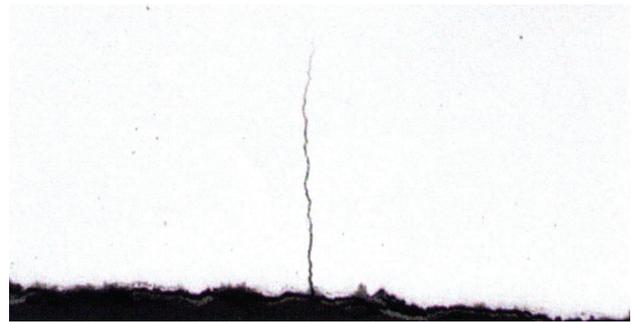
**Figure 7:** Crack located on the inner surface of the pipe (50× zoom)<sup>3</sup>  
**Slika 7:** Razpoka, locirana na notranjostipovršine cevi (50× povečava)<sup>3</sup>

Afterwards, the corrosion that was found on both surfaces of the pipe was examined. Pitting and small sharp projections were found on the inside. Some of the pits already had a character of small cracks (**Figure 7**), caused by a combination of corrosion and stress. Based on these findings, it was expected that the cracks had started on the outside of the pipe, in the area where the material was weakened by the small cracks from the inner side. Stress and the medium flow might be important during the process of crack growth and will be further examined.

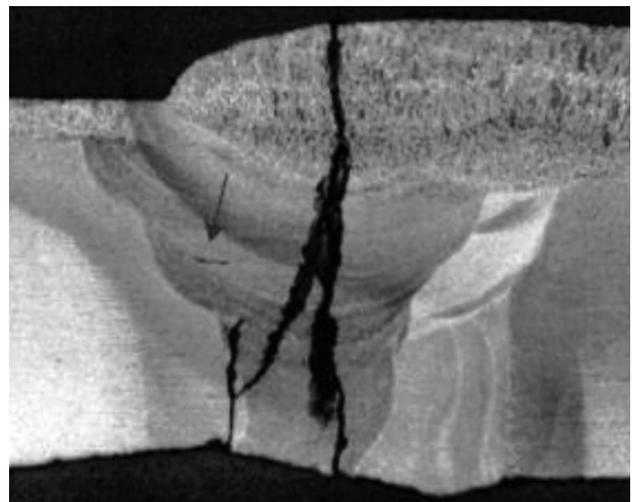
The second tested sample was taken from the area where the collector is welded to the U-shaped transition pipe. The crack goes through the whole weld and is divided into two branches in the middle of the cross-section (**Figure 8**). The crack is open mainly in the middle part and even with the microscope analyses, the direction of the crack formation could not be determined.

**Figure 8:** Weld macrosection with the crack (5× zoom)<sup>3</sup>  
**Slika 8:** Prerez zvara z razpoko (5× povečava)<sup>3</sup>

defects were found (see the black arrow in **Figure 8**). As mentioned above, this weld was repaired several times in the past so it was obvious that there was some problem with the equipment geometry (e.g., supports locations), stress and temperature dilatation.

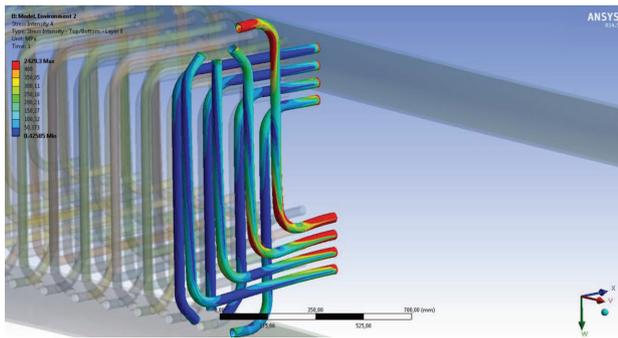
**Figure 9:** Stress intensity for bent pipes  
**Slika 9:** Intenzivnost napetosti na zvite/zavoje cevi

As can be seen on **Figure 9**, the stress intensity is crucial in the pipe bends, the exact location where the crack and leakage were discovered.

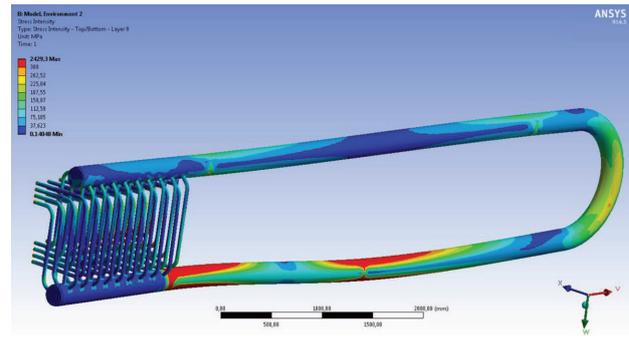
**Figure 10:** Stress intensity for the whole computational model  
**Slika 10:** Intenzivnost napetosti za celoten model

An improper use of the supports was confirmed by a higher stress intensity at the second problematic location including the collector and the U-shaped transition-pipe weld joint (**Figure 10**).

Based on these results, it was obvious that the problematic parts were the supports. They allow higher values of the total displacement of the U-shaped transition pipe that induce higher moments and stresses. Also, there is one support at the bottom part, which behaves like the center of rotation; thus, an additional stress is induced. The other crucial elements were the fixed supports of the collectors, located too close to the weld-joint location.
