## IMPELLER-BLADE FAILURE ANALYSIS

Roman Celin, Franc Tehovnik, Franc Vodopivec, Borut Žužek

Institute of Metals and Technology, Lepi pot 11, 1000 Ljubljana, Slovenia  
roman.celin@imt.si

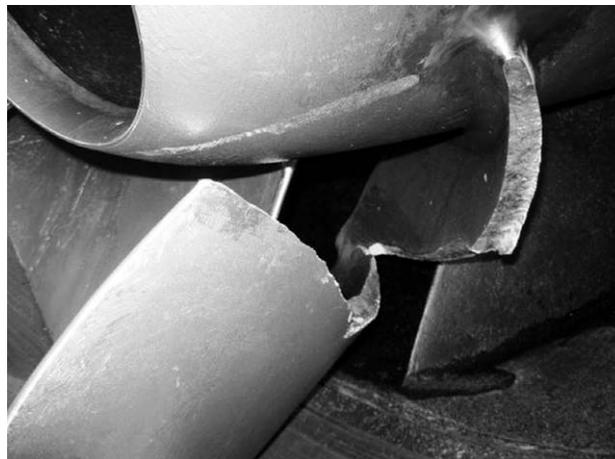
Figure 2: Damaged impeller blade  
Slika 2: Poškodovana lopatica rotorja

Twelve months after a plant outage a vertical, axial-flow, fresh-water pump, stainless-steel impeller failed. The hub and impeller blades were a single cast made of the ASTM A743 stainless steel (grade 316). This stainless-steel grade was a material of choice because of its good erosion-resistant properties. The axial-pump flow rate was  $Q = 8.453 \text{ m}^3/\text{s}$ , the head was  $H = 13.72 \text{ m}$  and the number of revolutions was  $n = 370 \text{ min}^{-1}$ . A complete pump assembly was dismantled and the maintenance crew immediately discovered a very distinct crack on an impeller blade (**Figure 2**). The pump owner decided to carry out a failure analysis.

The most obvious feature on **Figures 2** and **3** is the blade splitting over the entire hub. The crack propagated at an angle of approximately 30°–35° from the blade leading edge toward the outer edge. The visual examination of the other blades revealed a through-thickness crack at the leading edge of the blade marked as sample 1 and it is shown, in detail, on **Figure 5**.

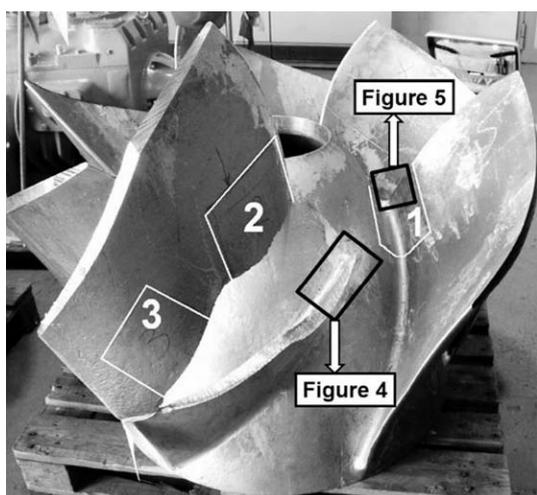
**Figure 3:** Positions of **Figures 4** and **5** with samples 1, 2 and 3 before the removal

ness from approximately 25 mm near the hub to an average of 10 mm at the top of the blade. **Figures 2** and **3** show that the cast surface of the blades and the hub was not ground. Several areas were detected on the blades and at the attachment zone of the blades and the hub (**Figures 4** and **5**) where weld-repair work on the cast was performed by the supplier.

The top of the blade started to rub against the inner ring surface and possibly the impeller operated in a damaged condition for some time. The material loss at the top of the blade, caused by friction wearing, is noticed on **Figure 3**.

The crack initial point on both blades (**Figures 3, 4** and **5**) was above the weld-heat-affected zone. It was not possible to determine the exact initial point of the crack on the blade leading edge. The crack surface was smooth and mostly plastically deformed due to the surface grinding during the pump operation.

Three samples (**Figure 3**) were chosen for further analysis. **Figure 5** shows sample 1 which was used for a fracture analysis, while samples 2 and 3 were used for manufacturing the tensile and Charpy V-notch specimens.

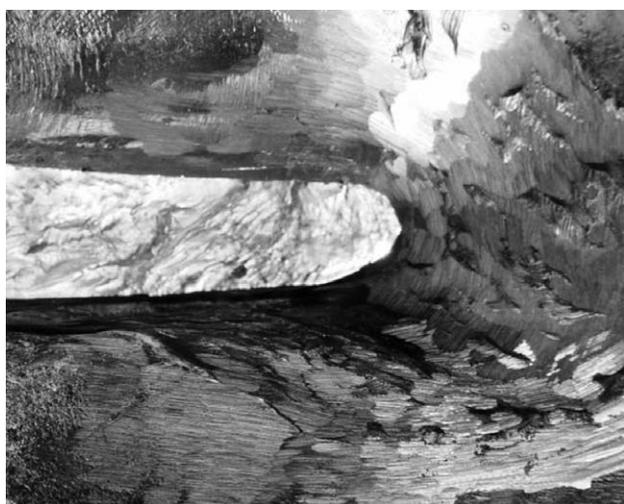
**Figure 4:** Crack surface with a repair-weld build up at the blade leading-edge attachment to the hub

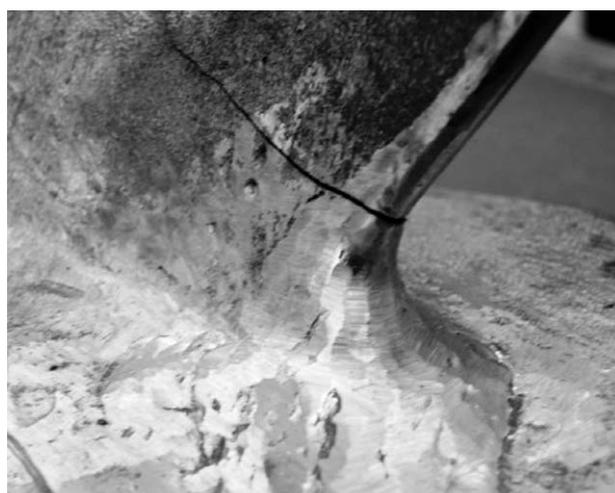
**Figure 5:** Crack at the leading edge of the blade

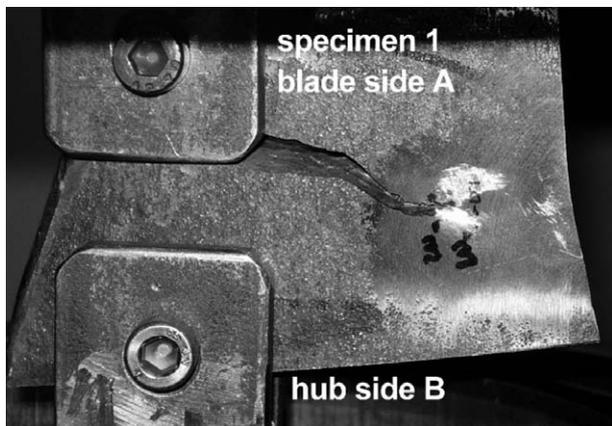
**Figure 6:** Sample-1 crack opening on a tensile-testing machine  
**Slika 6:** Razpiranje vzorca 1 na trgalnem stroju

**Figure 6** shows sample 1, cut from the hub, clamped on the tensile-testing machine with the purpose to obtain the fracture surface without any grinding or other damage.

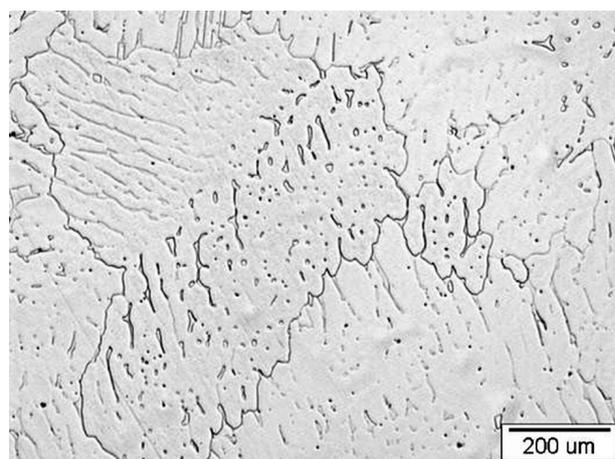
**Figure 7** shows the cast A743-steel microstructure of the hub at the blade side B of specimen 1 and **Figure 8** shows the microstructure of the blade leading edge (side A).

It consists of dendritic austenite grains with the inserts of  $\delta$  ferrite at some grain boundaries. The content of the  $\delta$  ferrite was of about 5 %. The microstructure shown on both pictures is without any peculiarity and it is typical for the cast stainless steel.

**Figure 7:** As-cast microstructure of the hub-to-blade attachment  
**Slika 7:** Mikrostruktura ulitka na stiku pesta in lopatice

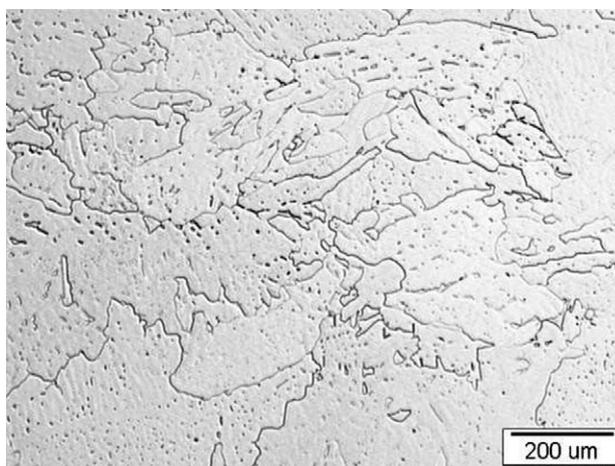
**Figure 8:** Microstructure of the blade leading edge (sample 1 – side A)  
**Slika 8:** Mikrostruktura roba lopatice (vzorec 1 – stran A)

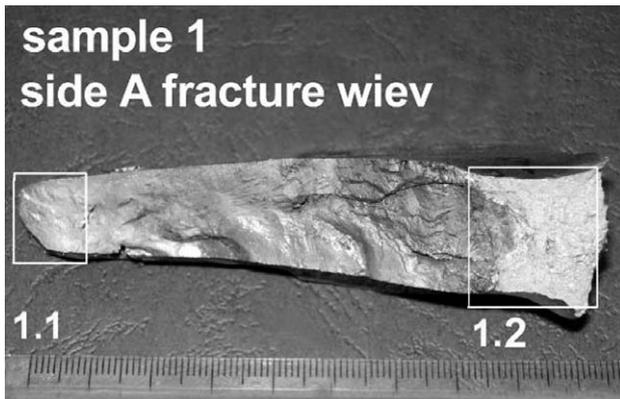
**Figure 9** shows the side-A fracture-surface view. The bright area (marked as 1.2) on the right is the fracture

**Figure 9:** Side-A fracture surface of sample 1  
**Slika 9:** Površina preloma na strani A vzorca 1

The sample-1 side-A fracture surface has the same features as the fracture surface shown on **Figure 4**. The surface is smooth and the mostly plastically deformed area marked as 1.1 (**Figure 9**) was carefully examined with an optical microscope. Because of the plastically deformed surface, the exact crack point of origin was impossible to ascertain. Also, the crack propagation mode could not be distinguished on the damaged surface (**Figure 10**) and the fatigue striations were not detected either.

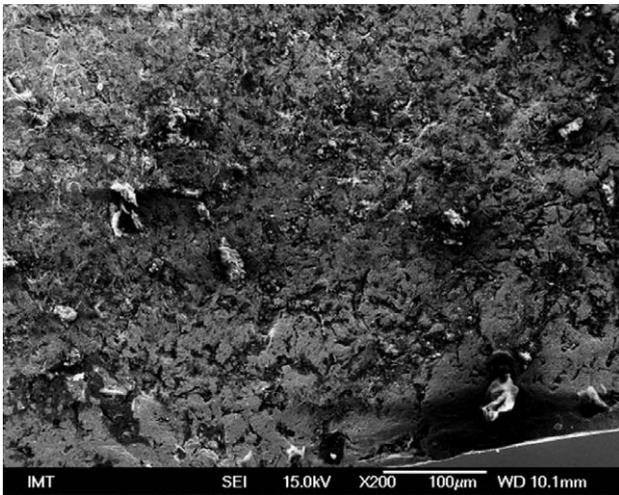
**Figure 10:** SEM image of plastically deformed surface area 1.1  
**Slika 10:** SEM-posnetek deformirane površine, označene z 1.1

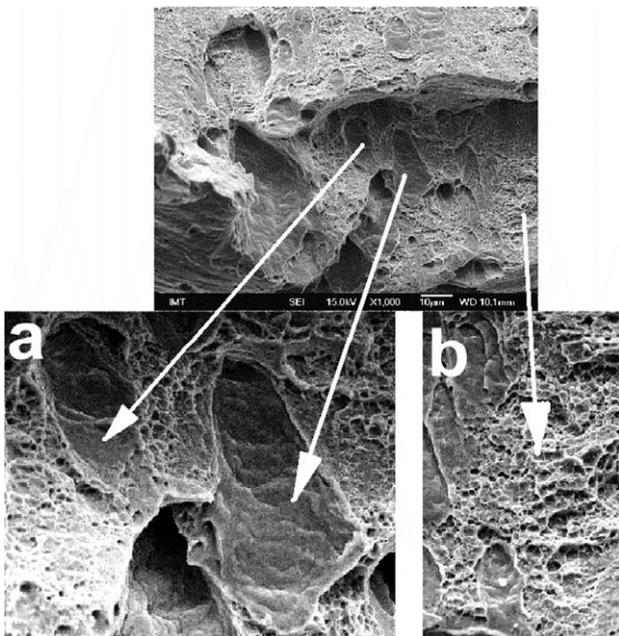
**Figure 11:** a) Interphase fracture and b) ductile fracture  
**Slika 11:** a) Medfazni in b) žilav prelom

The area (marked as 1.2 on **Figure 6**) enabled a SEM investigation of the fracture surface, and **Figure 11** shows two fracture modes. One (**Figure 11 a**) presents an interphase crack propagation on the interface of austenite and the inserts of  $\delta$  ferrite, while the other (**Figure 11 b**) looks like a ductile fracture with small dimples.
