ANALYSIS OF THE REASONS FOR THE LEAKAGE OF A BOILER WATER-WALL TUBE IN A POWER PLANT

Ruidong Guo¹, Song Xue^{1,2*}, Tao Yang¹, Xuedong Liu¹

¹College of Manufacturing Science and Engineering, Southwest University of Science and Technology, Mianyang 621010, China

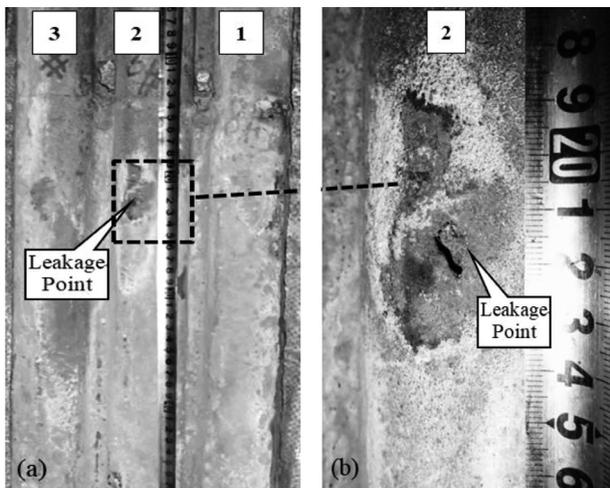
Visual inspection of the damaged water-wall tubes was used to check for signs of corrosion, leakage points and deformation etc., and the evidence was photographed. The position of the leakage area on the boiler water wall tube was shown in **Figure 1a**. An enlarged observation of the leakage area, the clear macro morphology of the leakage point was shown in **Figure 1b**. The oxidation layer on the surface of the water-wall tube was observed, but blackening and abnormal thickness were not found. To detect the condition of the tube's inner surface, the tube was radially sectioned, and a macroscopic view of the cross-section is shown in **Figure 2a**. The leakage area presents an inverted drop shape, and the thickness of leakage point position is thinned (the thinnest part is 2 mm). Deposits attached to the inner surface of the leakage area can be observed. Diameters measured at different locations of the tube wall are shown in **Table 1**. The variation in dimensions at the leakage area indicates a significant bulging and deformation occurred during the tube failure and the maximum diameter of the tube wall bulge position reaches 63 mm, which exceeds the original diameter of 60 mm. When the deposits are viewed from the inner wall, the internal thread characteristic can be observed. The color of the inner tube wall is reddish brown and the exfoliated metal covering the inner wall of the pipe, as shown in **Figure 2b**.

Figure 1: Photograph of failed water wall tube and the macro morphology of leakage point: a) the position of the leakage point, b) macro morphology of the leakage point

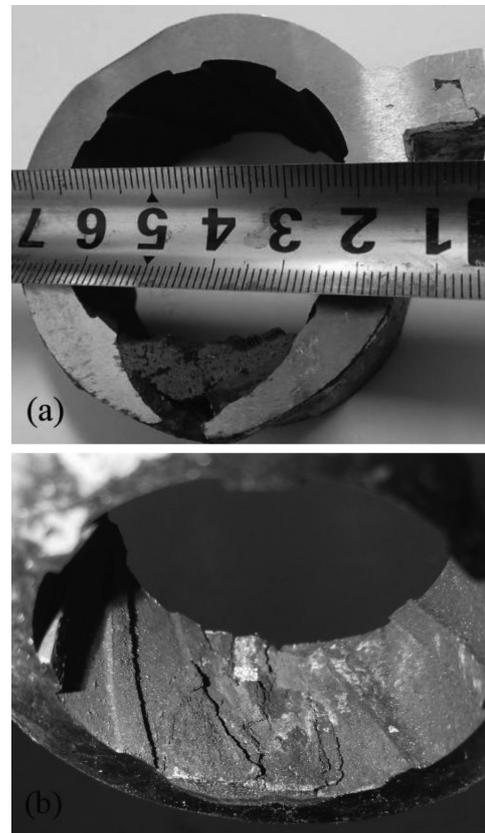
Figure 2: Close views of the tube at failed region shows: a) the morphology leakage point cross-section, b) the morphology of inner wall

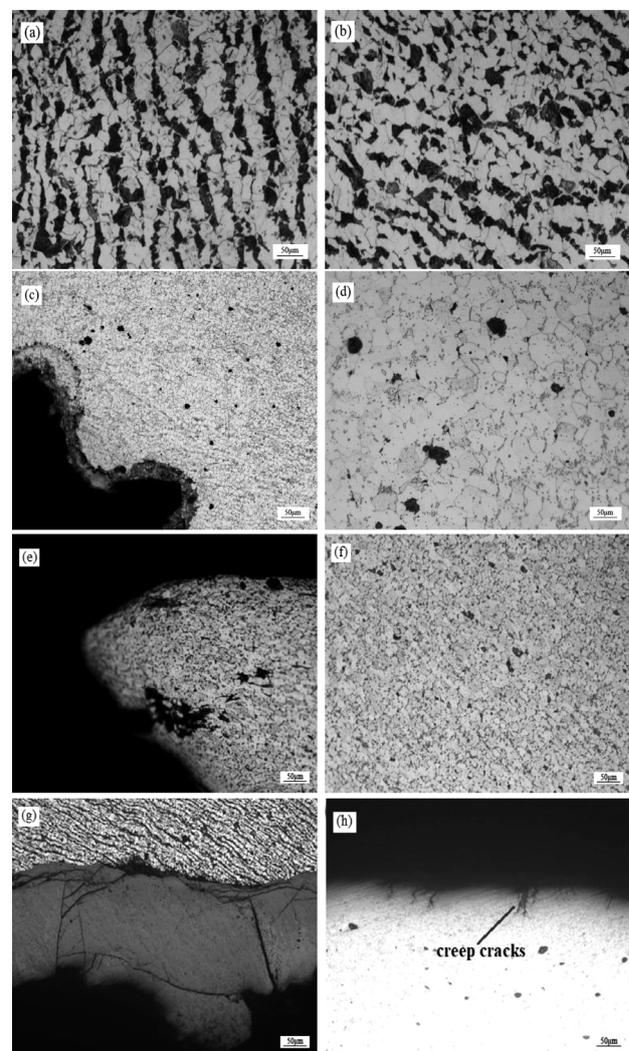
The microstructures of the failure tube and the normal tube were examined in detail, the aim to being know the microstructural constituent phases in the microstructures of the failed tube and the normal tube. The specimens were selected from different sections of the failed tube, then polished and etched with 2 % Nital solution. The metallographic structure of the failed specimens near the leakage point consisted of ferrite + pearlite structure, and pearlite was distributed in a strip, as shown in **Figure 3a**. The metallographic structure of the normal specimens was shown in **Figure 3b**, which is

also a ferrite + pearlite structure. All the microstructures of the test specimens conform to the standard requirements, and these test results are consistent with the test results of the contrast samples, conforming to the designated SA-210 Grade C steel. At the cross-section of the leakage point, creep holes were observed on the inner wall, as shown in **Figures 3c** and **3d**. The pearlite structure at the leakage point was seriously spheroidized due to overheating, and the grains were elongated due to plastic deformation (**Figure 3e**). Microstructure observations revealed that the grains were elongated, which indicates that plastic deformation occurs at high temperature. Overheating caused a degeneration of the initial ferrite–pearlite microstructure. Spheroidization and coalescence of the carbides occurred in the matrix of the boiler tube near the leakage-point region. At the edge

Figure 3: Microstructure obtained from different regions of boiler water-wall tubes specimens: a) microstructure near leakage point, b) microstructure of normal specimens, c) and d) creep holes, e) pearlite structure spheroidized and grains were elongated, f) precipitated carbides, g) deposits were attached to tube inner wall, and presented in a layered structure, h) creep cracks in the outer wall near the leakage point

of the leakage point, a severely spheroidized pearlite microstructure and a large number of precipitated carbides were observed, shown in **Figure 3f**. According to DL/T884-2004,25 the microstructure aging level near the leakage point was graded at 4.5. These microstructural changes were due to the atomic migration at high temperatures. When the temperature is above 280 °C and lower than the eutectoid temperature, the cementite in the pearlite spheroidized. Changing the shape of the layer of cementite to a sphere can reduce its internal energy. In **Figure 3g** the deposits were attached to the tube inner wall of the leakage point. **Figure 3h** shows that the deposits mainly presented in a layered structure, and the thickness of the tube thinned at the deposits' covered zone. Due to the deposits formed on the inner wall, which caused the local heat-transfer performance of the water-wall tube to decrease and the tube's overall performance deteriorated, creep cracks formed in the outer wall near the leakage point, as shown in **Figure 3j**.

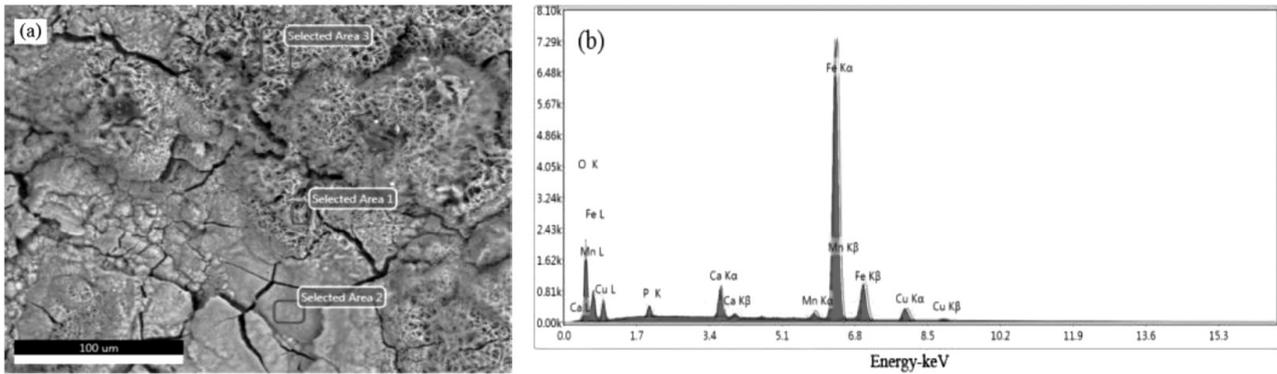
Figure 4: SEM morphology and EDS test results: a) SEM morphology of deposits covering area in the tube inner wall, b) energy-dispersive spectroscopy analysis of deposits

The chemical composition of the deposits on the inner wall is detected using energy-dispersive spectroscopy (EDS). The deposits sample was selected from the tube to determine the chemical composition. **Figure 4a** shows the inner wall morphology at the leakage position, with deposits present as the spallation state. The EDS test results are presented in **Figure 4b** and the deposits mainly contained Fe and O. Furthermore, the deposits also contained a few Ca, S, and Mn elements, as shown in **Table 5**.

Furthermore, the component analysis of the sediments separated and accumulated on the inner surface of the pipe near the leakage point was carried out with X-ray fluorescence spectrometry and the test results were listed in **Table 6**. According to the test results, it was found that the deposits consist of the compound (CaSO_4) and the corrosion products (Fe_2O_3), which indicate that the failed tube suffered a corrosion attack.

- Boiler sewage and water quality test should be carried out regularly to prevent deposits from forming on the inner tube wall. In addition, clean up the deposits formed in the inner tube wall in time to avoid local overheating of the tube.
- Preventing the boiler tube from exceeding the working temperature and working pressure, and regular cleaning with a boiler tube wall thickness inspection.
