AN INTEGRITY ANALYSIS OF WASHING-MACHINE HOLDERS

Nenad Gubeljak¹, Matej Mejac², Jozef Predan¹

¹University of Maribor, Faculty of Mechanical Engineering, Smetanova 17, 2000 Maribor, Slovenia

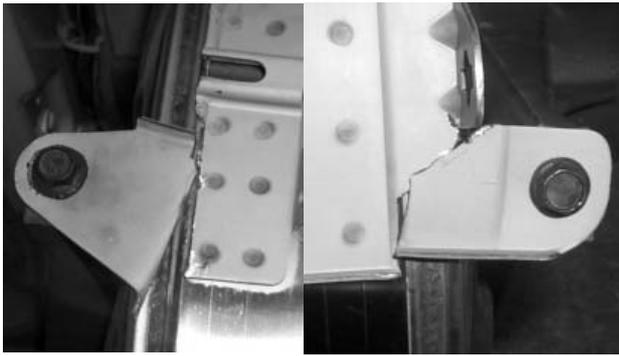
Figure 2: Broken outer holder without fatigue-crack propagation
Slika 2: Zlomljeni zunanji nosilci brez vidne utrujenostne rasti razpoke

The mechanical testing of a washing machine with an eccentric load was performed in the factory. The results showed that the number of cycles without fracture or crack formation is insufficient for the quality-control requirements. A failure analysis and inspection of the fractured parts showed that the initial fracture occurred in the central holders of the cross, while the fracture of the outer holders occurred at the end, when the inner holder was already broken, see **Figure 2**. Therefore, the aim of this study was to carry out a stress-strain analysis and a structure-integrity analysis of the inner holders of a washing machine's drum.

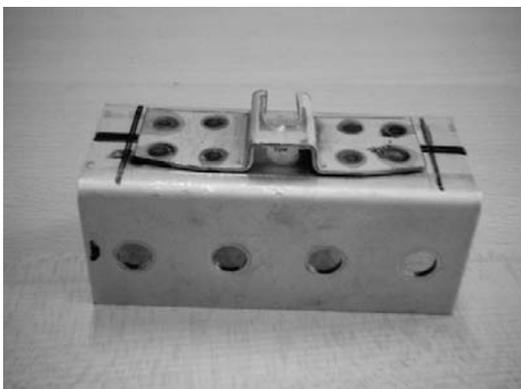
Figure 7: Holder welded by spots on pad for testing

factory. The holder was welded with eight spot welds, as with the washing drum, but in the laboratory case this was on a pad for testing, as shown in **Figure 7**. The holder was tested statically with tensile pulling until fracture, as shown in **Figure 8**. A graph of load vs. stroke was recorded, as shown in **Figure 9**.
