## CONTACT WITH CHLORINATED WATER: SELECTION OF THE APPROPRIATE STEEL

Leon Gosar<sup>1,2</sup>, Darko Drev<sup>1,3</sup>

<sup>1</sup>Institute for Water of the Republic of Slovenia, Hajdrihova 28, 1000 Ljubljana, Slovenia

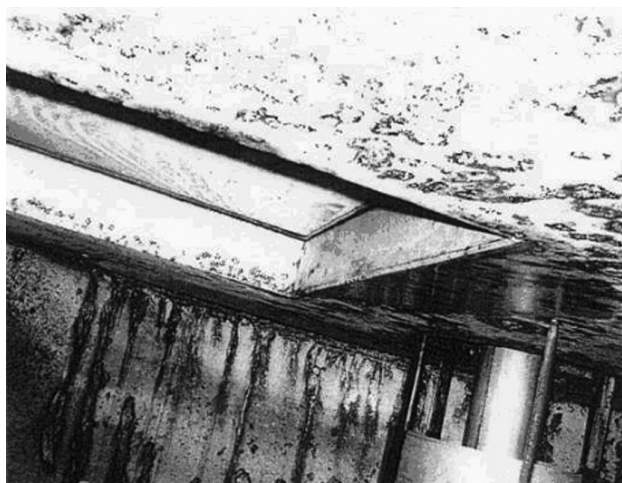
In the analyzed cases of the internal water-supply network, we found that multiple chlorine shocks and large concentrations of disinfectants (**Table 1**) resulted in the dissolution of zinc coatings on steel pipes. Corrosion also occurred inside stainless-steel water tanks (**Figure 2**).

**Figure 2:** Corrosion inside a cold water reservoir  
**Slika 2:** Korozija v notranjosti rezervoarja hladne vode

Extensive corrosion on all the surfaces of the reservoir has shown (**Figure 2**) that it could not result from conventional chlorine shocks alone, but instead required the presence of much higher concentrations of chlorine. This reservoir was constructed of stainless steel X5 CrNi 18-10 as recommended by the Deutsches Institut für Bautechnik for structures in contact with pool water that may be highly chlorinated. In the case of the water supply, disinfection with the recommended agents was employed to destroy the bacteria of the Legionella group (**Table 1**). Since this was not successful, the disinfection was repeated several times, each time with an increased concentration of disinfectants. When it was determined that the disinfectants were not appropriate, oxidizing agents effective for the removal of biological deposits and the destruction of Legionella bacteria were introduced into the system. This resulted in a corroded internal water-supply system and poor quality of the drinking water. However, by adding an oxidizing disinfectant based on hydrogen peroxide and small amounts of colloidal silver particles, one can indeed achieve microbiological water disinfection. However, this water will also likely be organoleptically and chemically unsuitable <sup>9</sup> due to the resulting water-pipe corrosion.

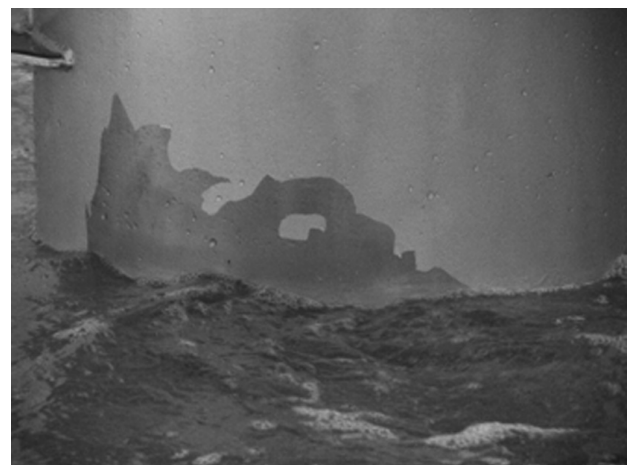
stainless steel. However, this did not ensure adequate protection; as shown in Figure 4 the protective layer peeled off the protected surface and consequently the investor enforced the warranty for the waterslide structure.

**Figure 4:** Protective coating peeling off of stainless steel structure  
**Slika 4:** Prikaz slabe površinske zaščite nerjavečje jeklene konstrukcije v kopalnem bazenu
