THE IMPACT OF STAGNANT WATER ON THE CORROSION PROCESSES IN A PIPELINE

Marjan Suban, Robert Cvelbar, Borut Bundara

Institute of metal constructions, Mencingerjeva 7, 1001 Ljubljana, Slovenia
marjan.suban@imk.si

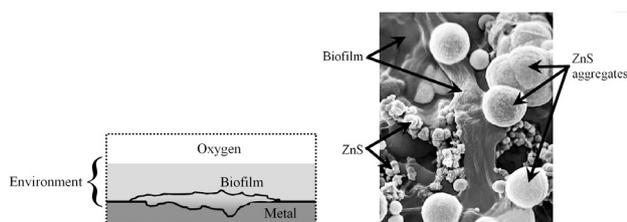
Therefore, in the case of ferrous alloys SRB cause the formation of iron sulfide (FeS). In the case of a reaction with zinc (Zn), which represents the corrosion protection of steel, the corrosion products are zinc sulfide (ZnS) and its aggregates, which can be found in biofilm, as is shown in **Figure 1** (right).

Figure 1: Components of the environment for the development of MIC (right) and microscopic photograph of biofilm in the case of zinc corrosion (left) ³
