## ROOT-CAUSE ANALYSIS OF SUPERHEATER-TUBE FAILURE

Martin Nad', Jiří Buzík, Tomáš Létal, Pavel Lošák

Brno University of Technology, Faculty of Mechanical Engineering, Institute of Process Engineering, Technická 2,  
616 69 Brno, Czech Republic  
nad@fme.vutbr.cz*Prejem rokopisa – received: 2016-07-15; sprejem za objavo – accepted for publication: 2016-09-15*

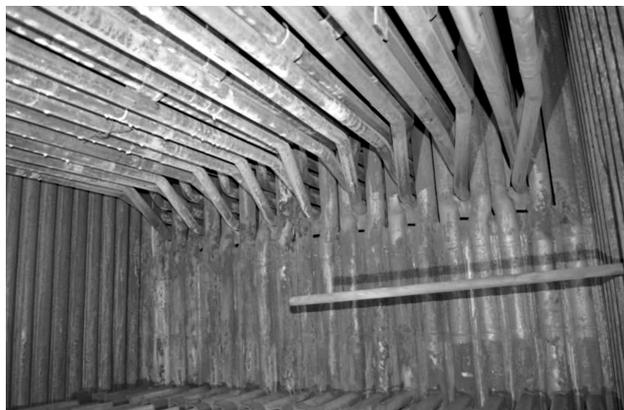
The construction of these superheaters is classic, widely used all over the world. Both of them are similar, having the same dimensions and being situated one above the other. The output chamber of superheater P1 is connected with the input chamber of superheater P2 by the U-shaped transition pipe. Each superheater has 9 pipes in 4 rows (a total of 36 pipes), which go through the membrane wall, with which they are connected by a seal-weld joint (**Figure 1**).

**Figure 1:** Part of superheater P1 and the membrane wall  
**Slika 1:** Del super grelca-pregrevalnika P1 in stena membrane

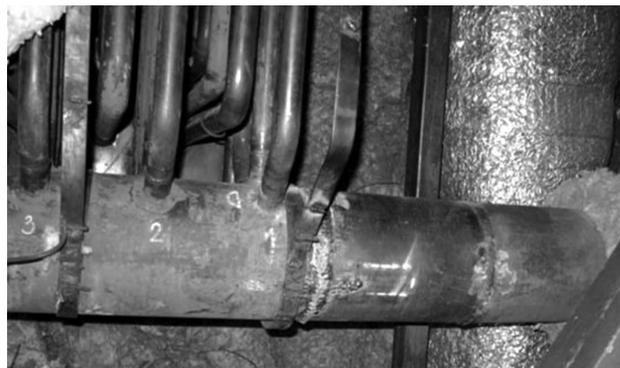
Superheater collectors are supported by two fixed strap iron profiles (**Figure 2**).

**Figure 2:** Support of the superheater collector  
**Slika 2:** Del zbiralnika v pregrevalniku
