A STUDY OF THE SONIC RESONANCE OF THE FEMORAL PART OF HIP ENDOPROSTHESIS

Igor Belič^{1*}, Beno Klopčič², Andraž Logar², Monika Jenko^{1,3}, Drago Dolinar^{4,3},
Matevž Gorenšek^{5,3}, Boštjan Kocjančič⁴

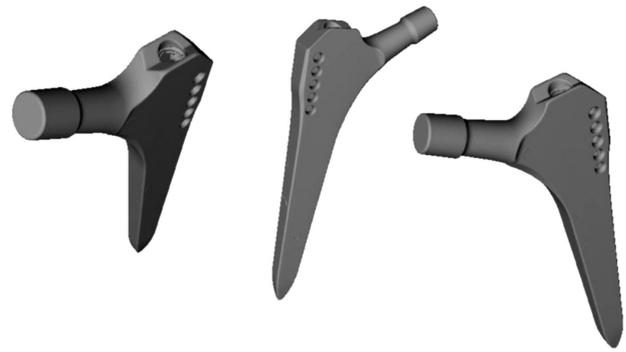
Figure 3: 3D scanned femoral part of a hip endoprosthesis.

To simulate the oscillation of the femoral part of the hip endoprosthesis, samples were scanned by a 3D scanner. The geometric structure was captured (Figure 3) and the simulation of its oscillation was performed.

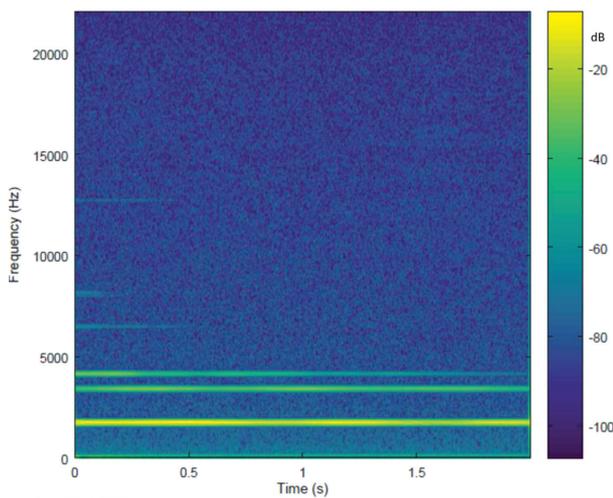
Figure 1: Sonogram of a femoral part of hip endoprosthesis. The sound was excited by striking the femoral part with a metal rod.

Sonograms show very distinctive and narrow resonance curves with one major resonance peak (2323Hz) followed by several higher harmonic peaks (Figures 1 and 2).

From Figures 1 and 2 it is clear that the main resonance frequency at 2323 Hz remains active for a very long time, while higher harmonic frequencies decay faster. The resonance phenomenon happens because of favourable conditions that are met by the given material density and the geometrical shape of the femoral part. Both conditions define the sonic oscillations at the resonance frequency. Generally, there are two possibilities to avoid the resonance. First, is the choice of material, which because of the other properties that are required for the implant, is very much limited. The density of the material can be controlled though the porosity (something that can be compared to the bone structure) and can nowadays be achieved using 3D-printed metals. Another

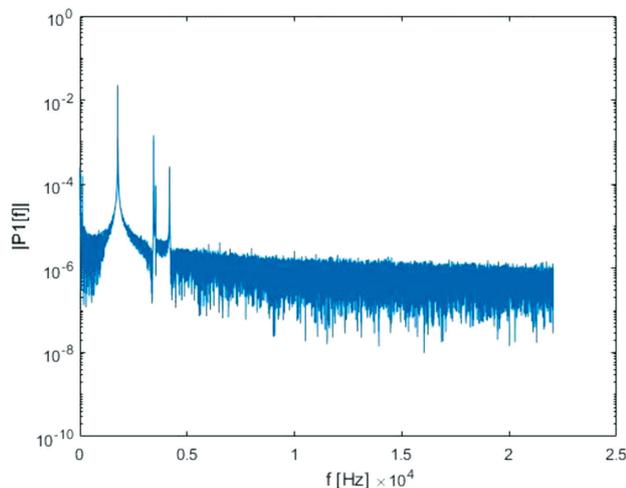
Figure 2: Frequency spectra of the oscillations of a femoral part.

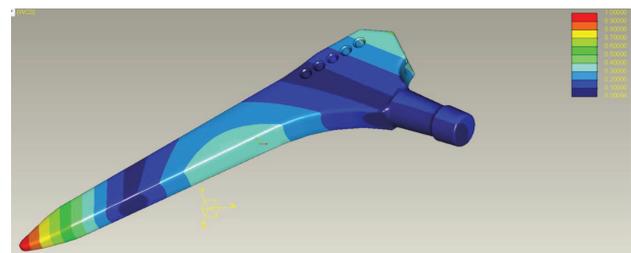
Figure 4: Simulated standing waves of the oscillated femoral endoprosthesis at 2323 Hz. The colour represents the relative amplitude of the oscillation.

From Figures 4 and 5 it is clear that the standing waves produce different oscillating amplitudes at different places of a femoral hip endoprosthesis (red colour represents high amplitude while the dark blue colour represents low amplitude). The problem that occurs is that the resonance frequency produces high oscillation amplitudes always at the same places on the endoprosthesis.

Since the endoprosthesis is mounted in a bone tissue, the same places in the bone are being constantly subjected to grinding. The rough surface of the endoprosthesis, which is purposefully being roughened in order to provide better osseointegration, due to the vibration, effectively grinds the bone. The problem with a resonant endoprosthesis is that it is constantly being subjected to the sound that is originating in a human body or it is coming from the outside. The resonator picks the sounds and oscillates at the resonance frequency.

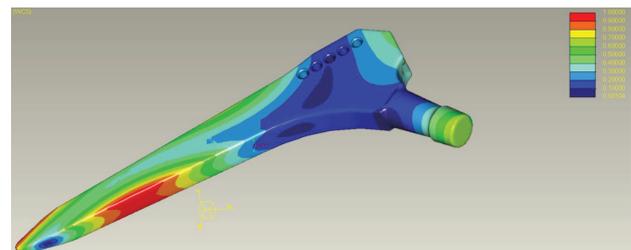
Figure 5: Simulated standing waves of the oscillated femoral endoprosthesis at 7170 Hz. The colour represents the relative amplitude of the oscillation.
